# Factory Pro Tech

## Bike kicks out of 2nd gear under acceleration?

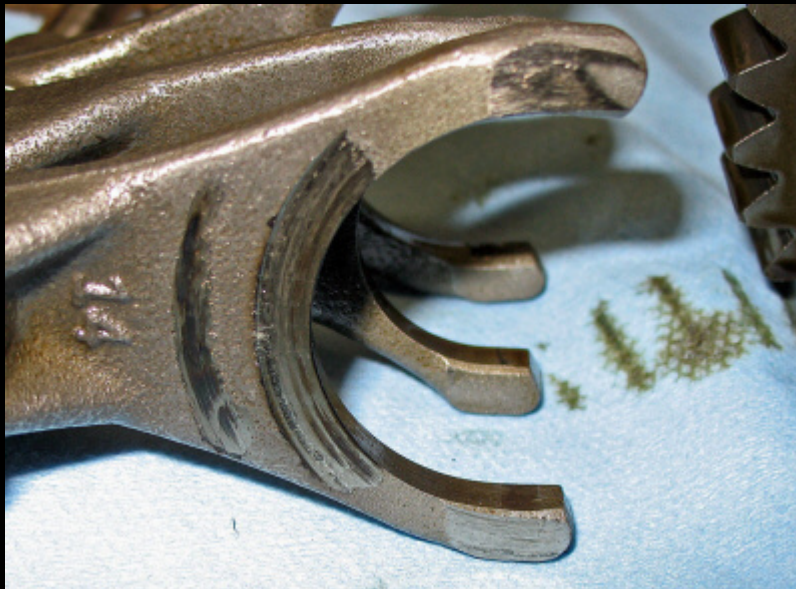
Typical damage to motorcycle gearboxes, symptom, kicks out of second gear (or any gear).  
This damage is caused by the bike "kicking out" of gear.

When the transmission "kicks out" of gear, the gears slip out of dog / slot engagement (because the shift drum hadn't turned fully before the rider let out the clutch and applied the throttle) - the 2 relatively spindly fingers or "tines" of the shift fork get bent and now, the gear drags on the body of the fork. You could bet that the ends of the fork's fingers and the other deep score are probably pretty parallel on their scored surfaces.

This is a 100% definite part to replace.

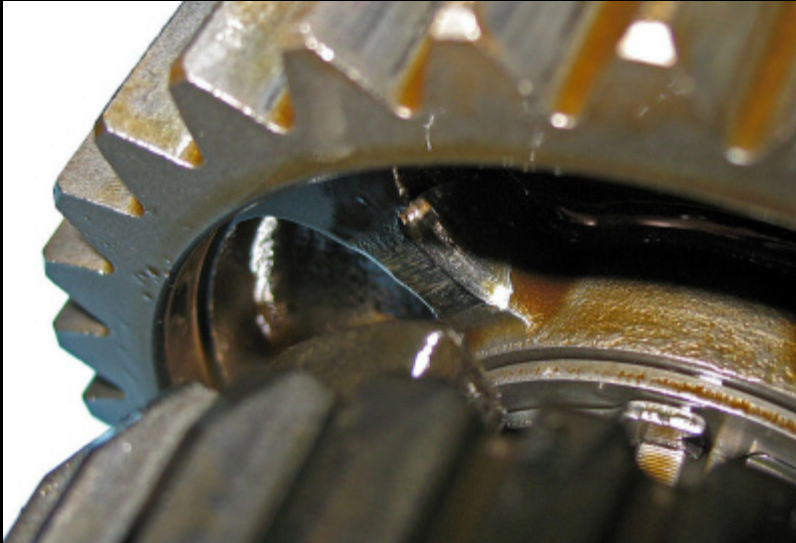
It got bent when the rider got back on the throttle before the shift was internally completed.

The gear's dogs and slots only got partially inserted because the shift drum hadn't fully rotated..... a little vibration and force, the dogs bounced back apart with an incredibly large amount of force - enough to bend the above shift fork.

Hmmm..... When the shift fork gets bent, it doesn't slide the gear over as far as it used to... and that makes the dog engagement problem even worse.

With a bent fork, the gear pops out even more often, rounding the dogs and slots and bending the shift fork even more.....

95% of the time, replacing just second gear, the gear it mates with and the corresponding shift fork will get you back to the starting line.

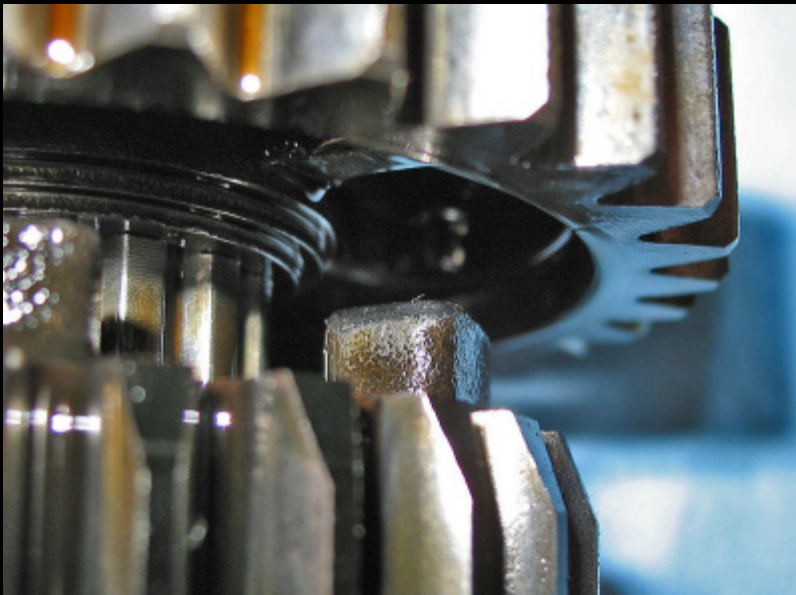
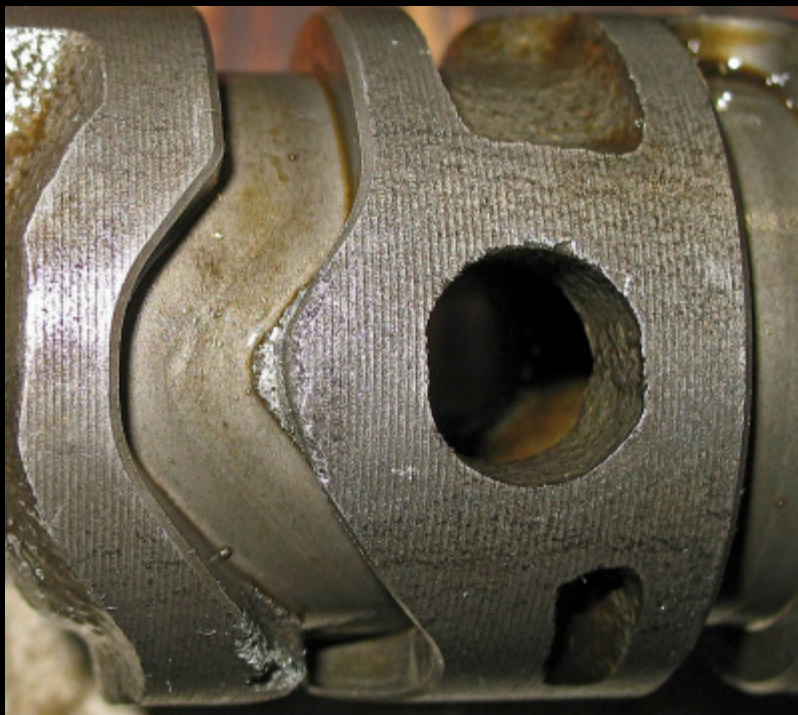
If the bike has been kicking out of second gear (or whatever gear gave a problem) for a long enough time, you'll get shift drum damage, too.

Just to the left of the round hole, you'll see that the left aimed "point" of the slot's path has been hammered away.

In this cbr900's case, the fork was bent and not pushing the gear far enough into it's mating gear, the dogs and slots were worn rounded, wanting to spread apart, the drum was worn and not pushing the fork far enough over.

Second gear was essentially "gone" at any amount of throttle...

Always inspect the shift drum pathways for damage.

That's pretty much it - a shift fork, 2 gears, some transmission clips (never reuse old clips and MAYBE a shift drum, plus gaskets and seals.

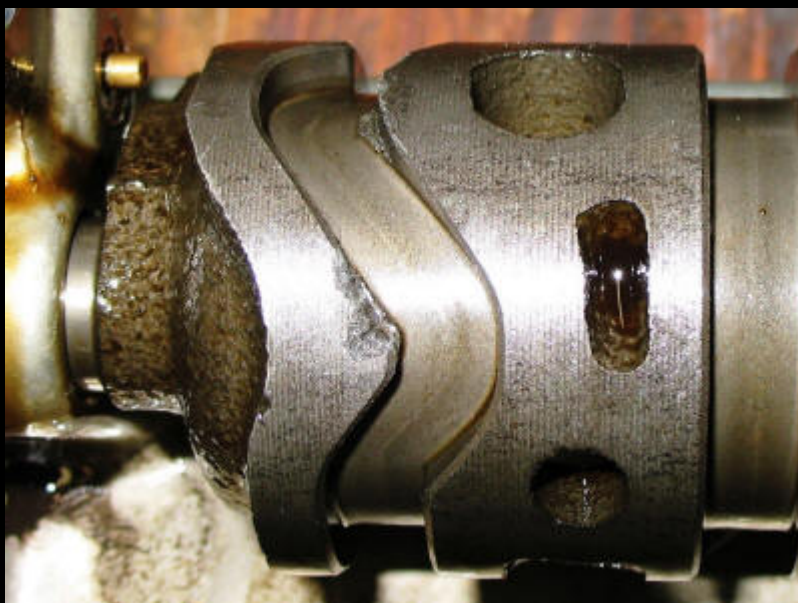
This is the first drum I've seen with damage to TWO different gear locations.
