# Factory Pro Tech

## Bike kicks out of 2nd gear under acceleration?

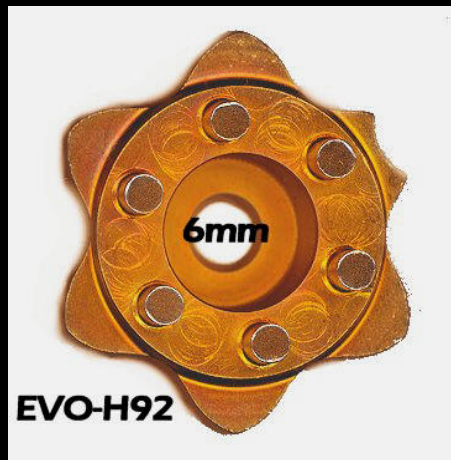
If the bike has been kicking out of second gear (or whatever gear gave a problem) for a long enough time, you'll get shift drum damage, too.

In this cbr900's case, the fork was bent and not pushing the gear far enough into it's mating gear, the dogs and slots were worn rounded, wanting to spread apart, the drum was worn and not pushing the fork far enough over.

This is the first drum I've seen with damage to TWO different gear locations.

Always inspect the shift drum pathways for damage.

Simple, all this damage is caused by missed shifts.
